Confidential ASHI Home Inspection Report

132 Hillside Road
Wayne, PA 19087
3/30/2024

Prepared for: Agnes Warren POA Eva Garami

SUMMARY OF MAJOR POINTS OF CONCERN

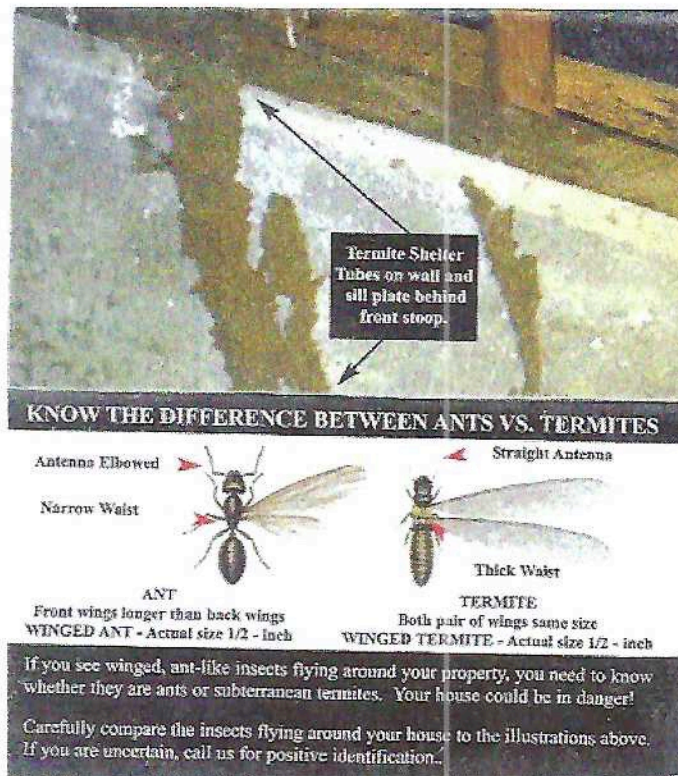
O.2. Unrepaired damage. Houses are built to code and codes are an established minimum.

Wood borers simply weaken the framing. Unrepaired damaged areas should be reinforced.

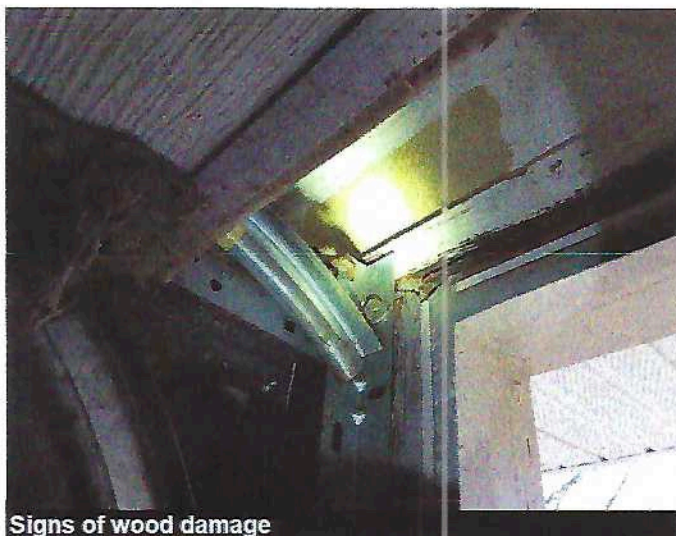
O.3. Reference the wood destroying insect report for complete information. There are signs of termite activity, but no signs of treatment. Intact mud tunnels. Damaged framing lumber. Explore further to determine the degree of damage. Repair damaged framing lumber prior to settlement. The house may need to be treated. Disclosure states "no" and "unknown" to termite questions.

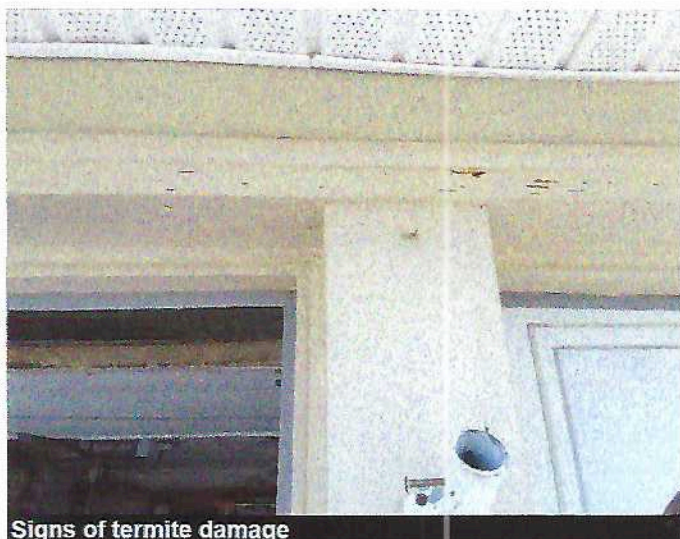
The chairman wood framing between the two garage doors shows termite damage. Have the wood destroying insect warranty company inspect for current activity. There is an intact mud tunnel at the top of the garage door jamb.

There are signs of termite treatment in the porch.
Reference the new wood destroying insect report.
House will most likely need to be treated again.

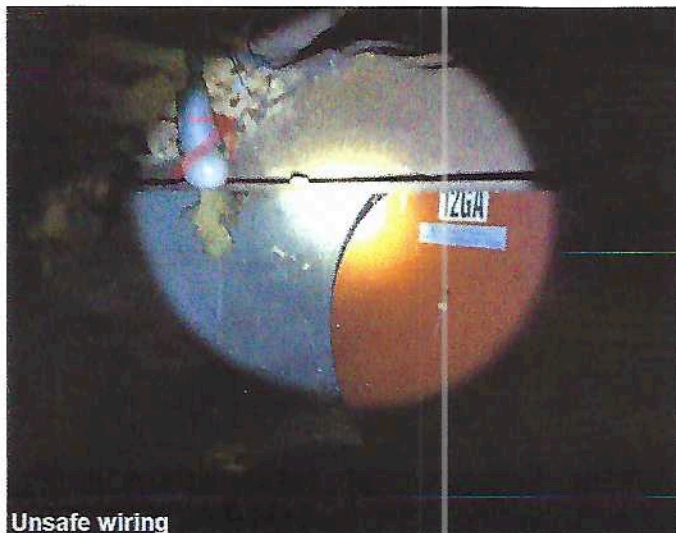
Unsafe wiring in the crawl space near the I-beam and oil tank.
Make connections safe and put in a box.

Action: Have an electrician examine and make all necessary repairs as soon as possible. Power line may need to be relocated. The utility company might add an additional wrap on wires near windows. A masthead might be needed to help gain altitude over a yard or driveway. Perhaps a wire could be placed in a protective conduit or put inside an electrical box. Simply adding knock out covers on the panel will protect access to the hot bus bars. Add GFI protection where electricity is too close to water-whirlpool, bath, shower, etc. Contact hazards are usually not terribly expensive to repair but pose a serious safety concern especially to children.

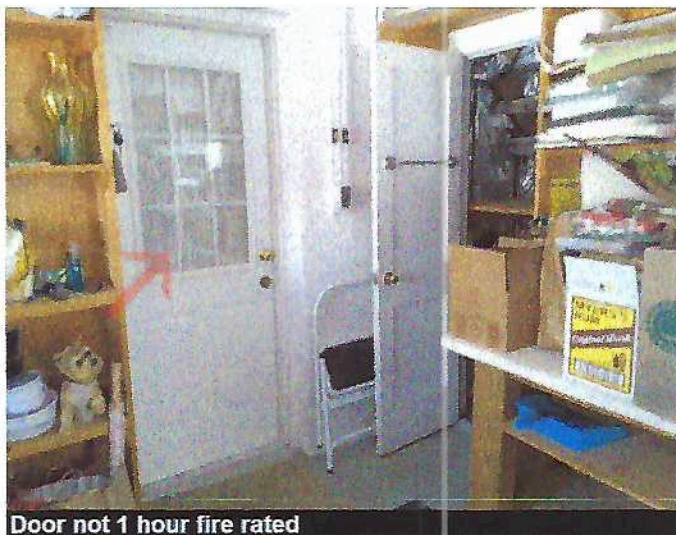
E.8. The garage to the house door is not one hour fire rated. Either replace with a steel insulated door or add a protective covering such as metal.

Action: This task is best left to a professional contractor. Add protective coverings. Add a double layer of fire rated drywall over a garage attic hatch. Add a metal cover over garage pull down stairs. Add a metal cover or replace the garage to house door with a steel insulated door. Patch any holes or openings. Fire rated drywall may need to be installed on a gable to house wall. Studs and drywall may need to be installed in a common attic-one shared between one unit and another. Repair this safety concern as soon as possible.

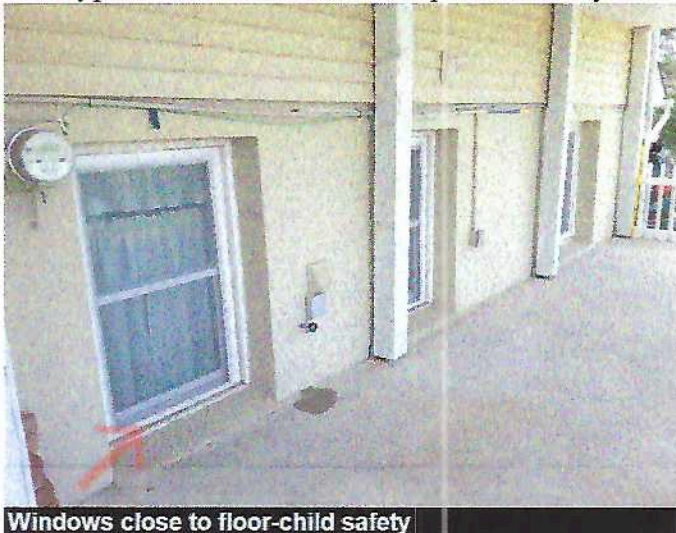
G.7. Windows close to floor pose a child safety concern. Add a clamp on window jamb.

The family room and powder room windows that border the porch are close to the floor. This type of window installation poses a safety concern to small children.

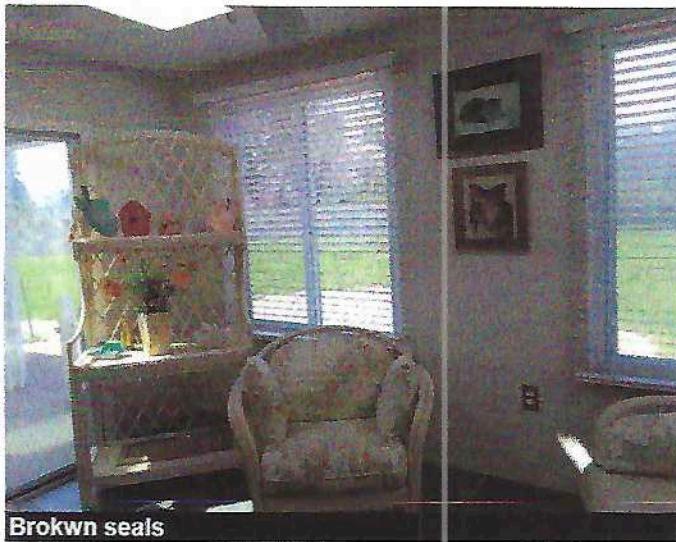
G.5. Clouded between panes. While it is not expensive to replace a couple of glass seals, the problem is typically compounded by the sheer number of broken seals.

Broken seal in sunroom rear right corner and fixed panel on slider.

Loss of seals can be repaired. Most windows and door glass can be replaced. As can the glass in skylights (but this is generally very difficult to access). Economically, sometimes it is better to replace the window rather than repair it. While replacing one or two sashes is not that expensive, repairing a dozen can cost in the thousands. Replacing the entire window is even more expensive. Don't depend on a warranty to cover the repair. Contact a glazier, glass company, to inspect all glass seals and quote for repair.

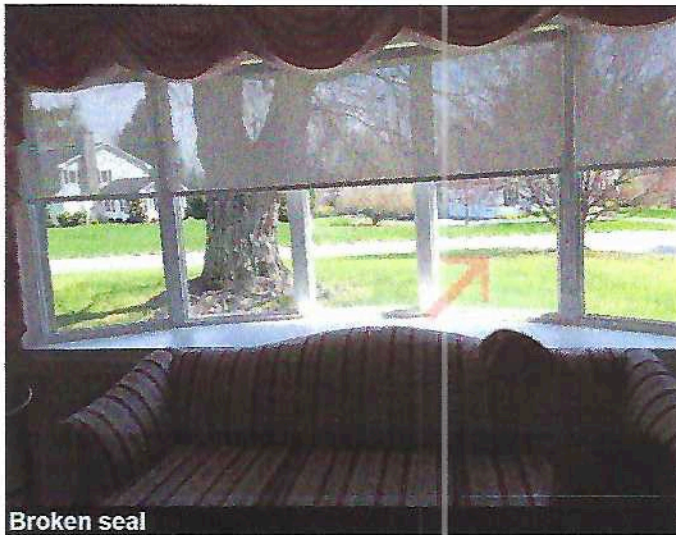
Bay window fixed sash second from right.

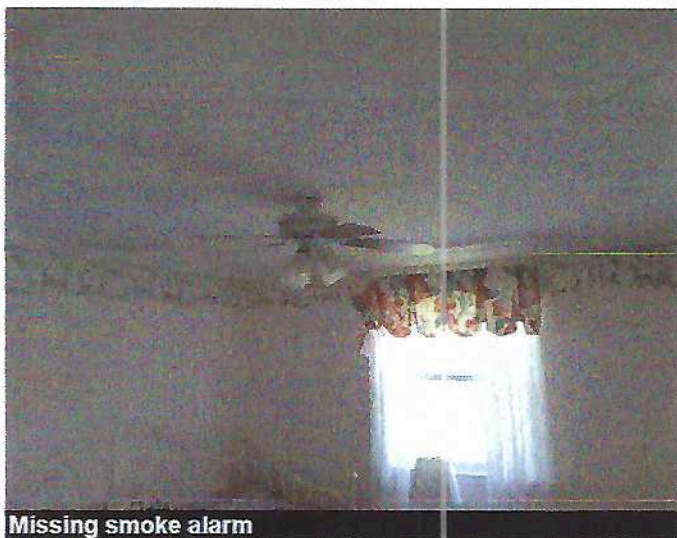
Q.2. Missing. Add a smoke alarm immediately.

Action: Safety first. Install smoke alarms and carbon monoxide alarms right away. Best to use 10 year batteries. Replace smoke alarms that may be a decade old. Either get a smoke alarm and carbon monoxide alarm combination device or install a stand alone CO detector. There are wall outlet plug in versions for a quick and easy installation. Carbon monoxide is the leading cause of poisoning in the US.

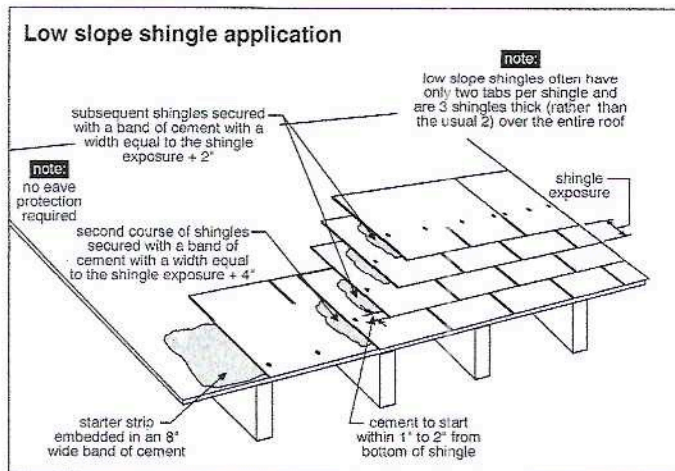
G.4. Inappropriate shingle application. The roof is installed on a less than 4/12 pitch with full reveal on the shingles. This type of roof application is more prone to leaks. Anticipate a shorter life. Replace with a flat roof material when replacing.

Action: Inappropriate shingle application installations are most prone to leakage after heavy snows and in high wind conditions. Often the snow in contact with the asphalt shingles melts from the heat below, runs down the roof, is blocked from running off the roof by snow at the eave, then leaking inward. Strong wind can drive surface water under the shingle edge onto the structure underneath. A roof sag can be corrected when re-roofing. A new substrate-wood or styrene, can be installed over the existing decking to create a proper slope. Another solution might be to add a roof drain at the bottom of the sag to drain the puddle when the new roof is being installed. This type of repair is best left to professional roofers. Inspection limitation: The area under the roof shingles will not be exposed to view. Their condition and effectiveness cannot be visually determined.

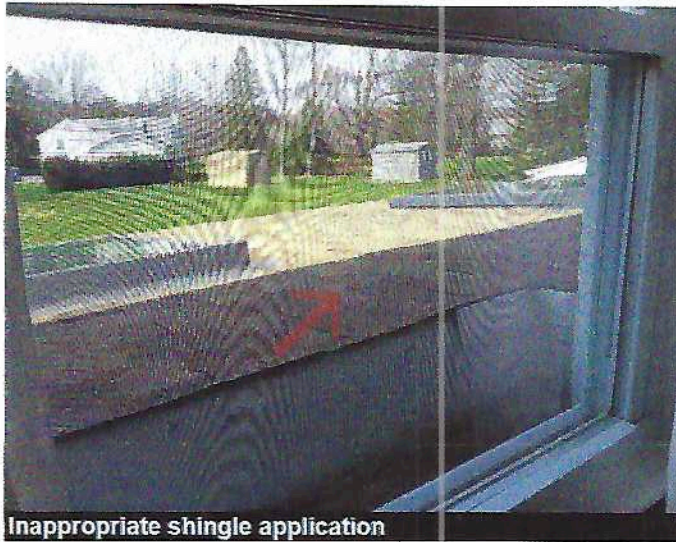
The rear porch roof has a low pitch with fiberglass shingles on a full reveal. This type of roof installation is more prone to leak especially in the snow.
