Confidential ASHI Home Inspection Report

132 Hillside Road
Wayne, PA 19087
3/30/2024

March 30, 2024

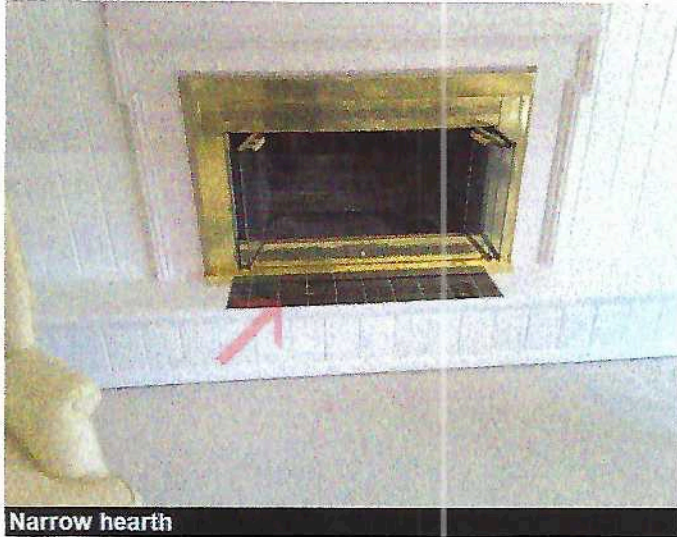
Flue access is sealed with a styrofoam panel restricting visual access.
