Confidential ASHI Home Inspection Report

132 Hillside Road
Wayne, PA 19087
3/30/2024

Prepared for: Agnes Warren POA Eva Garami

SUMMARY OF MAJOR POINTS OF CONCERN

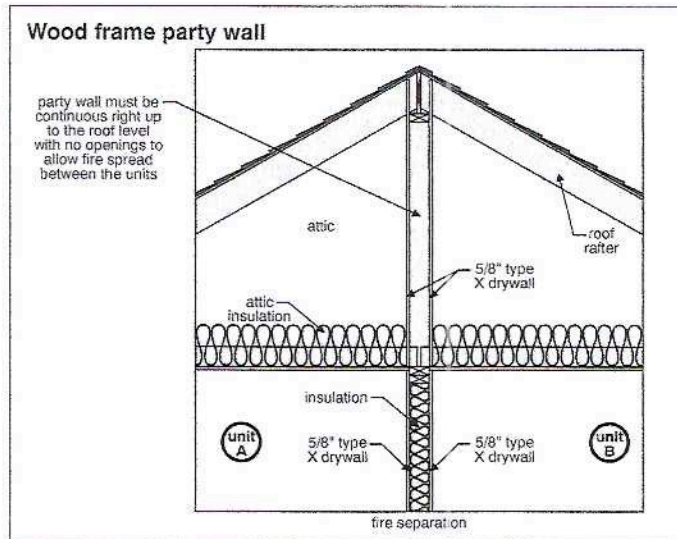
door. The gable in the garage or attic should be one hour fire rated. The safety requirements have steadily increased over the years. The concern is safety.

E.8. The garage to the house door is not one hour fire rated. Either replace with a steel insulated door or add a protective covering such as metal.

Action: This task is best left to a professional contractor. Add protective coverings. Add a double layer of fire rated drywall over a garage attic hatch. Add a metal cover over garage pull down stairs. Add a metal cover or replace the garage to house door with a steel insulated door. Patch any holes or openings. Fire rated drywall may need to be installed on a gable to house wall. Studs and drywall may need to be installed in a common attic-one shared between one unit and another. Repair this safety concern as soon as possible.
